NQA Audit Non Conformance and Corrective Action Submission Form

CLIENT NAME: University of the Arts London
 REPORT NUMBER: 572883
 DATE: 10/11/2021

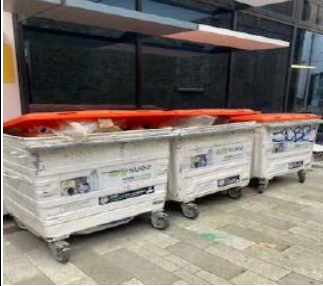
Ref No.	Standard & Clause No.	Statement of Non-conformity & objective evidence to support finding	Minor / Major
NC 02	8.2	<p>Site – CAMBERWELL college of Arts</p> <p>The location of the general and mixed recycling bins is unsuitable due to being located within an entrance point and by fire exit doors to the university. This can cause issues in the event of emergency evacuations.</p>

Minor
Containment Action			
The bins will be located away from the building as soon as possible			
Root Cause Analysis			
None identified			
Corrective Action			
The Estates Department have allocated funds remodel the entire area to install a lift and allocate areas for material storage, including bins. Please see Appendix One for design drawings			
Planned completion date for above actions		1 st September, 2021
